DESIGNING STABLE FOUNDATIONS

6.1 INTRODUCTION

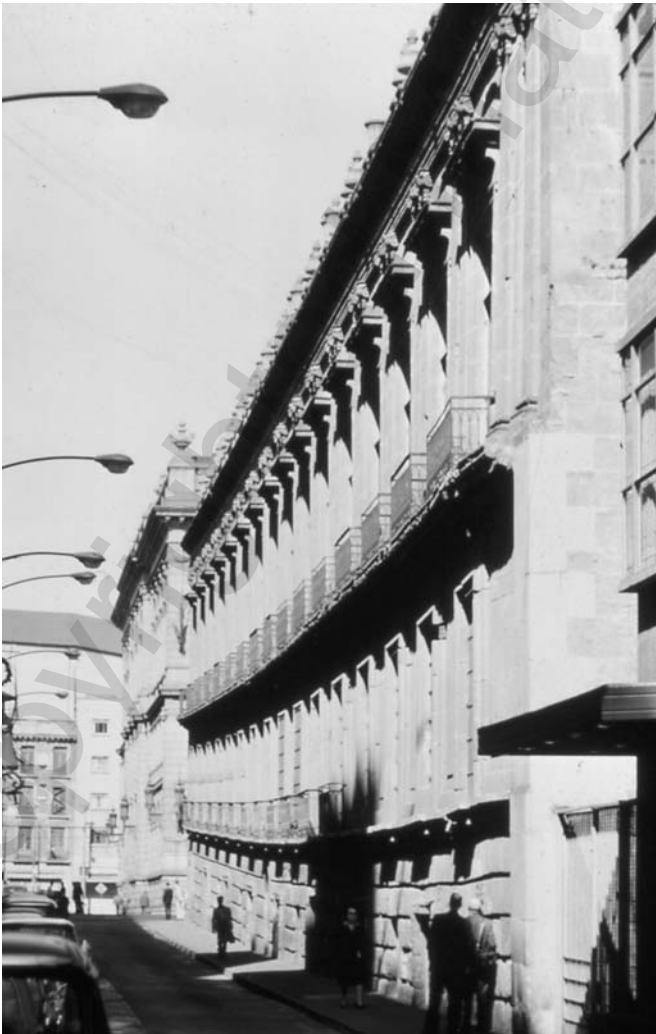
Figure 6.1 Photograph showing settlement of a government building in Mexico City.

deep-seated aquifers over many years caused several feet of subsidence in the Valley, and stresses from the foundations of major structures caused additional settlement due to the compressible nature of the soils. Zeevaert (1972) presents a profile to a depth of 80 m of the highly stratified subsurface soils in the Valley, with many meters having water contents averaging 200% and some strata with water contents as high as 400%. Settlement due to soil consolidation can be significant. Settlement in Mexico City is illustrated by the view of a government building (Figure 6.1). The building remained in use even though the settlement was much more than what might be tolerated at a site with less extreme soil conditions.

Cummings (1941) noted that “There is no question but that Mexico City is one of the most interesting places in the world for field studies in the settlement of structures. Whereas it is often necessary to search carefully for structural settlements with precise leveling and other accurate methods, the observation of structural settlements in Mexico City can be done by the eye without the use of measuring instruments of any kind.”

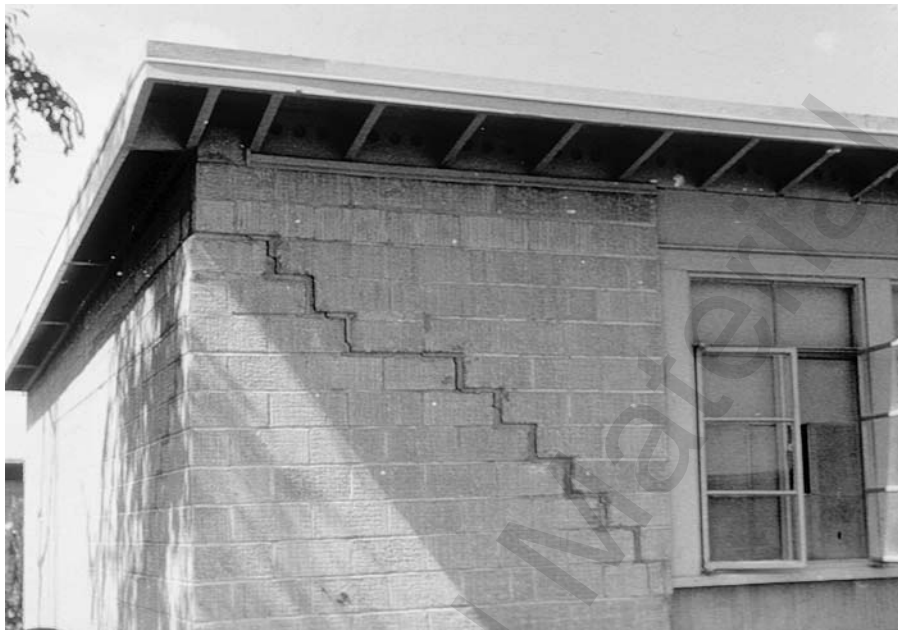
Figure 6.2 Damage to a masonry structure on expansive clay.

Clay expands as it becomes wet and shrinks as it dries. Furthermore, moisture will collect when evaporation is cut off. In addition to swelling of the clay, other important factors are the nature of the foundation, weather, and transmission of moisture through the clay. A foundation on expansive clay may show no distress for perhaps years and then experience severe movement. On the other hand, one of the authors was asked to visit a site where a church building had cracks in the walls so wide that people in the congregation could see children in a playground. However, a rain had occurred the night before, and when the author arrived, the cracks were virtually closed! Figure 6.2 shows the cracking of a structure on expansive clay.
